Fire Behaviour of Steel and Composite Floor Systems

Review of Real Fires

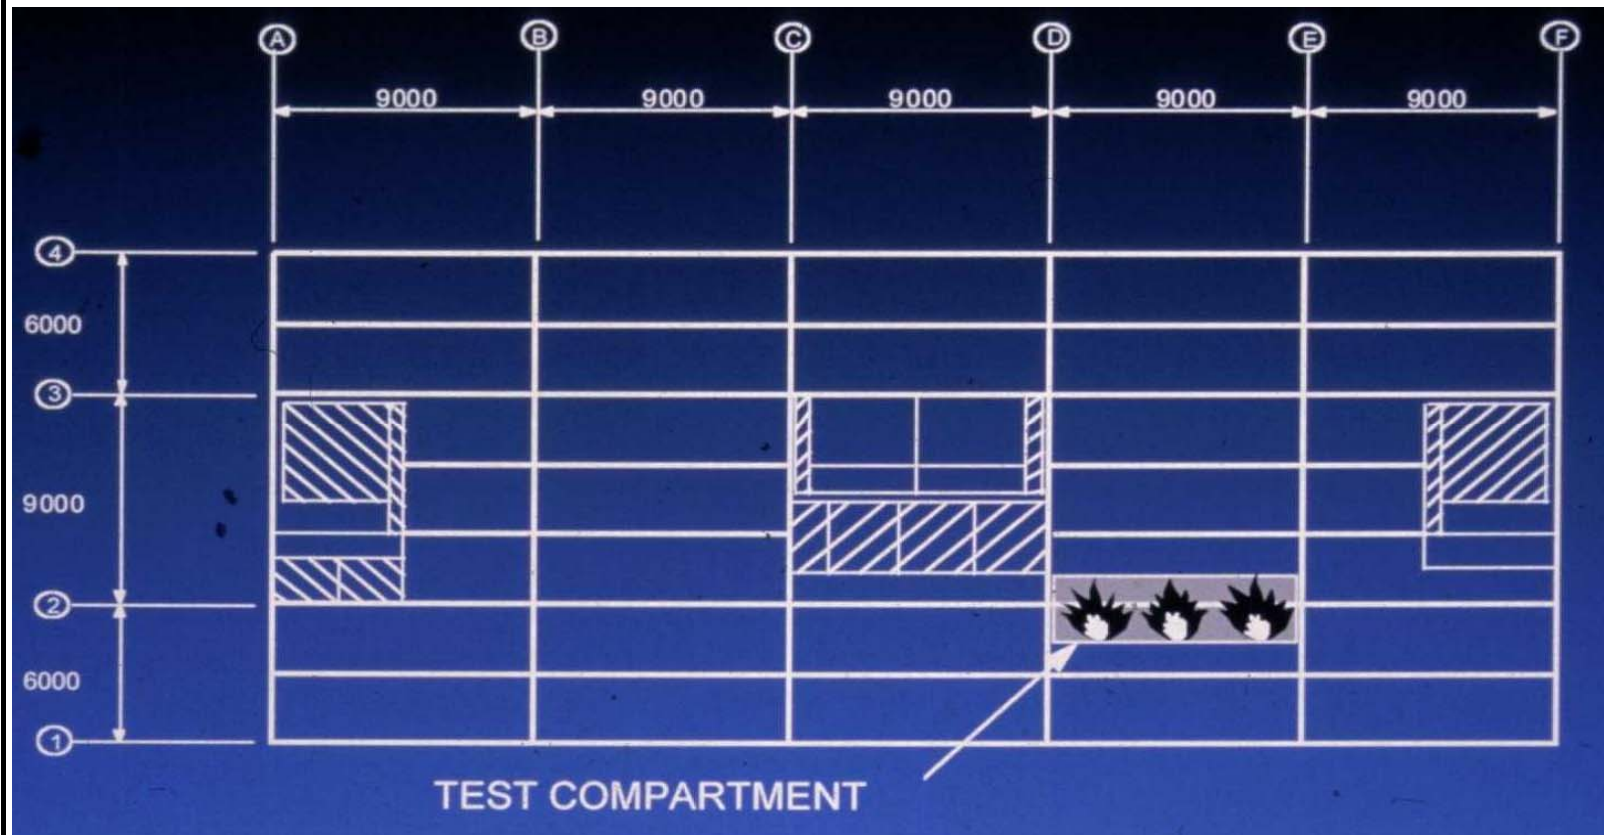
- Restrained beam test : span = 9.0 m

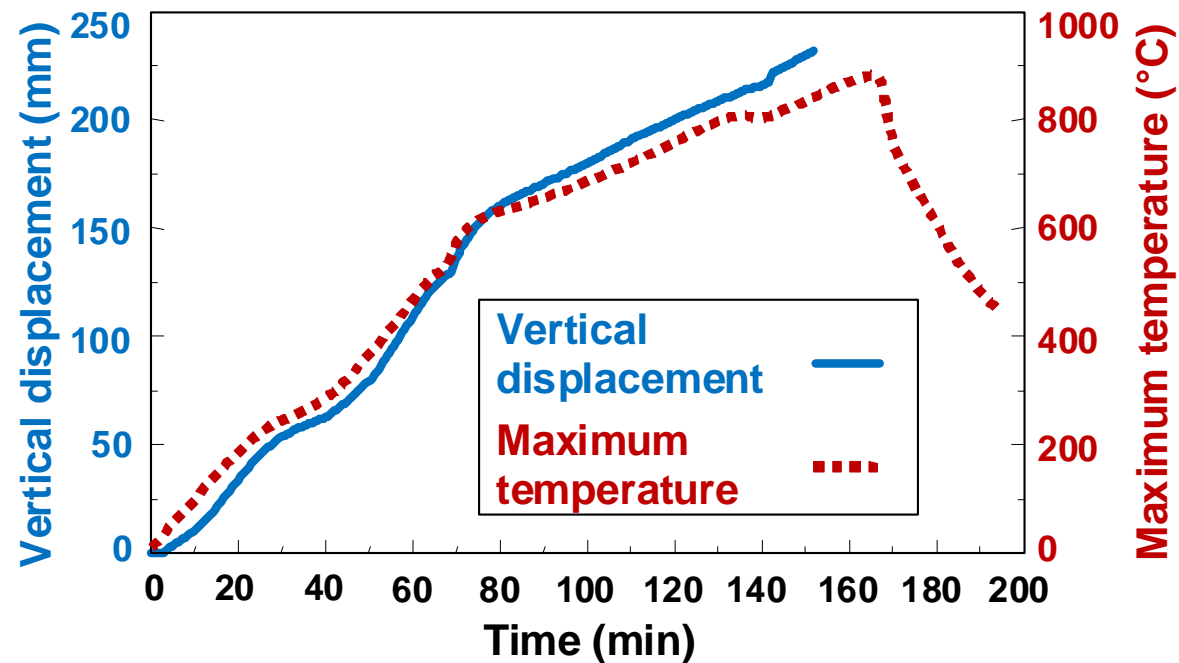
- **Restrained beam test : experimental results**

- **Observation**
 - Maximum heating $\approx 900\text{ }^{\circ}\text{C}$
 - Deflection of the beam: $< 250\text{ mm}$

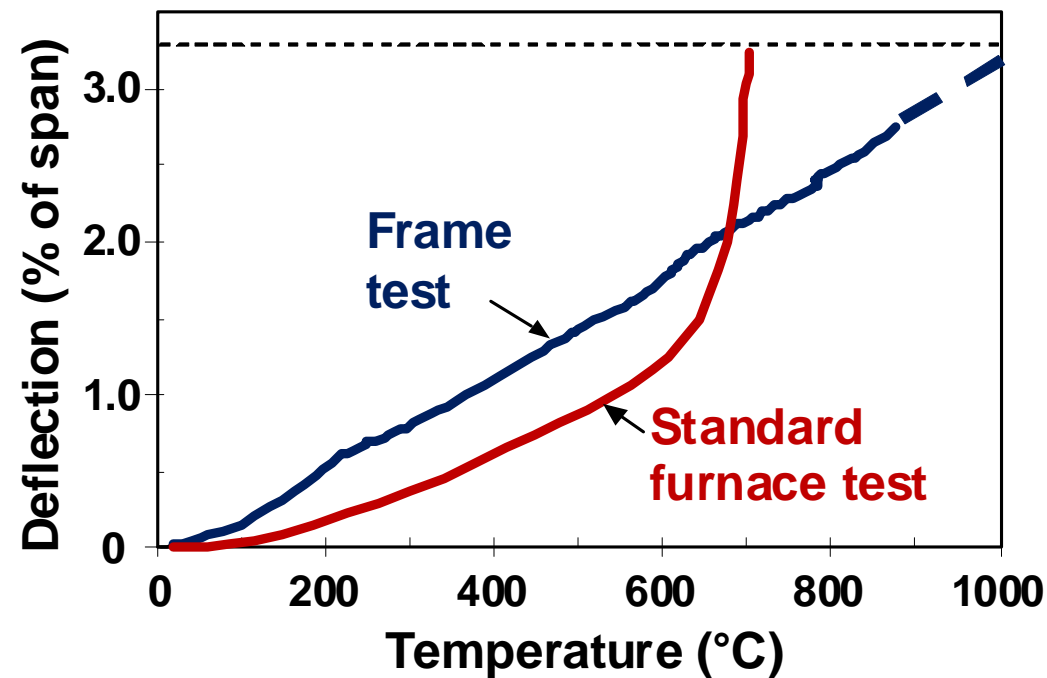
- Comparison with standard furnace fire test

- Conclusion
 - No sign of failure in global composite floor system
 - Collapse at $\theta \approx 650^\circ\text{C}$ if simply supported

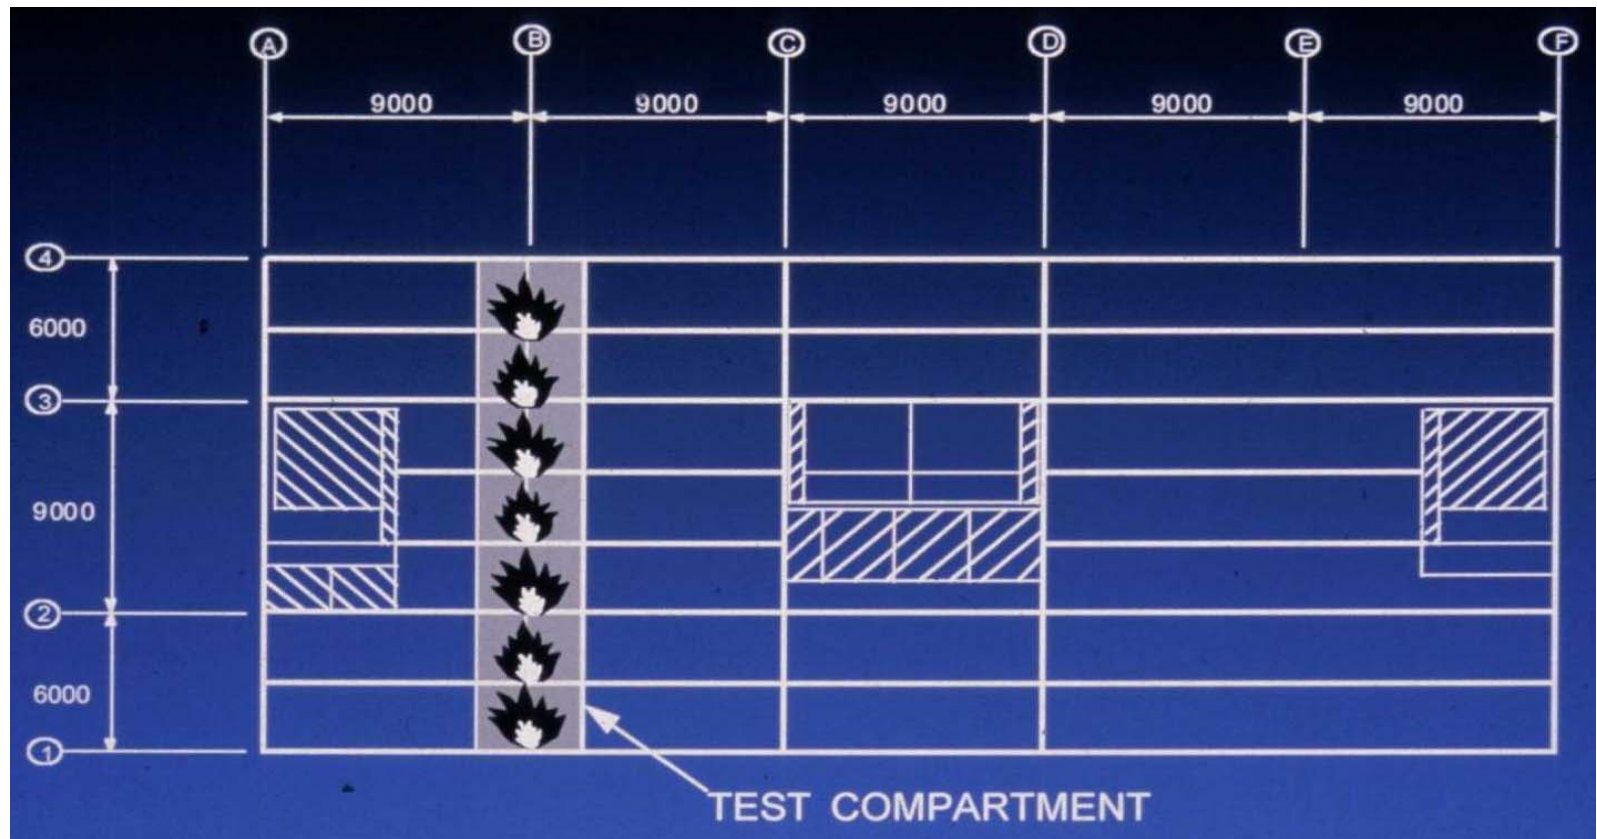
- Plane frame beam test

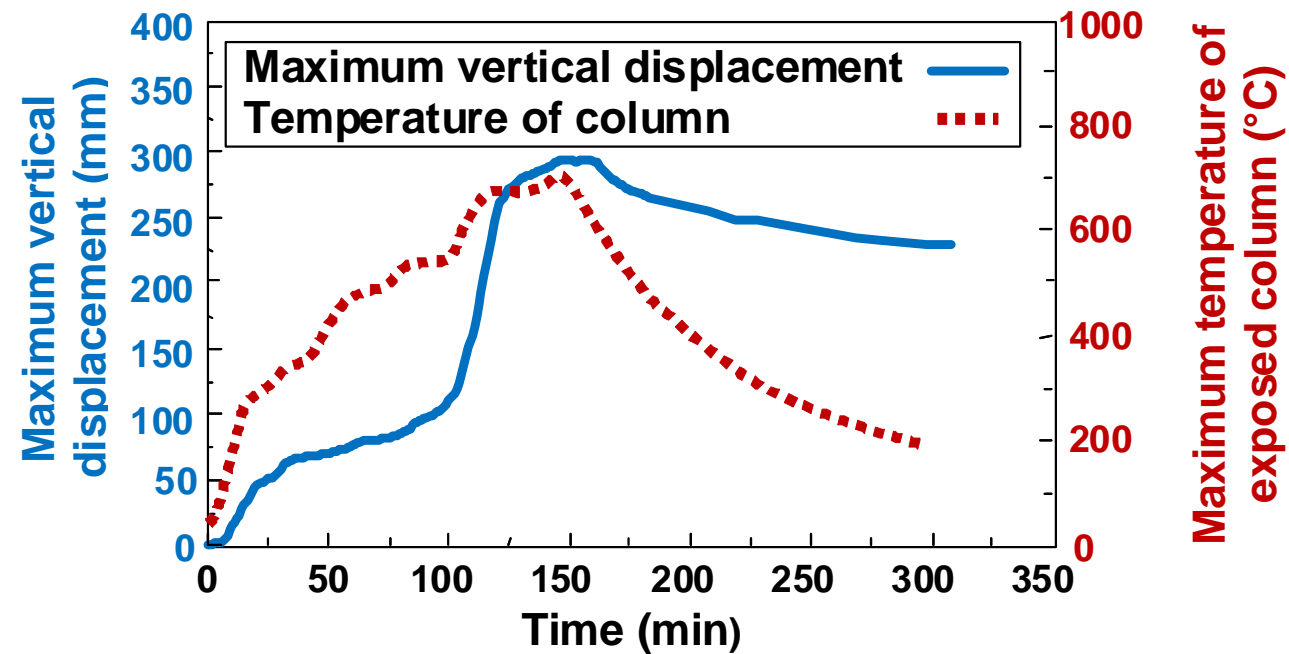
- **Plane frame test : experimental results**

- **Observation**
 - Maximum heating $\approx 750\text{ }^{\circ}\text{C}$
 - Deflection of the beam $\approx 300\text{ mm}$

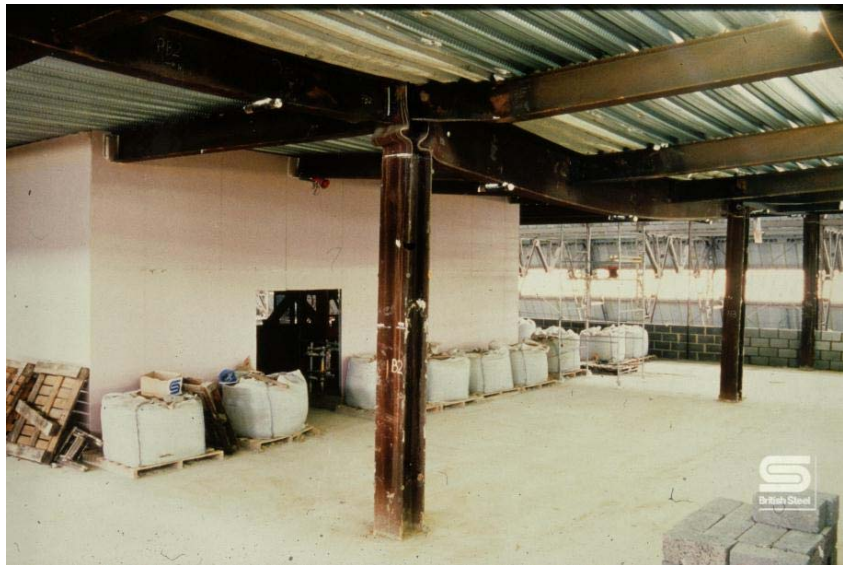
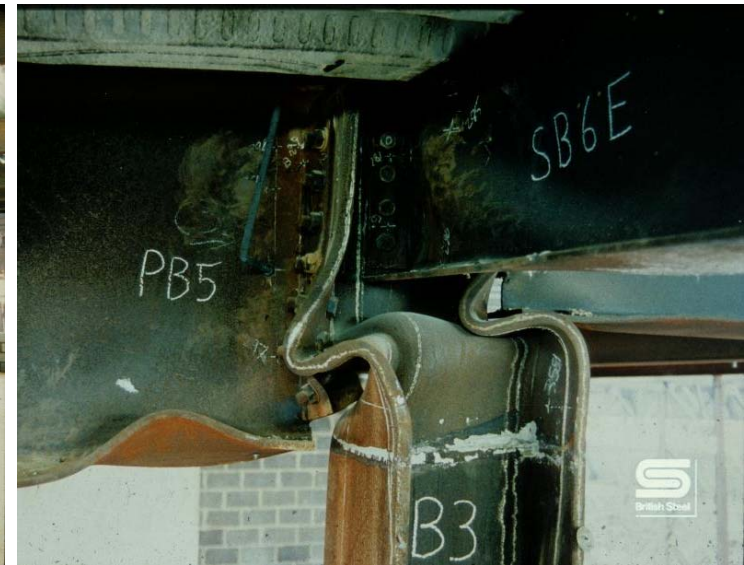
- Deformed state of heated part of the floor

- Conclusion
 - Squashing of unprotected part of column
 - No further collapse despite above local failure

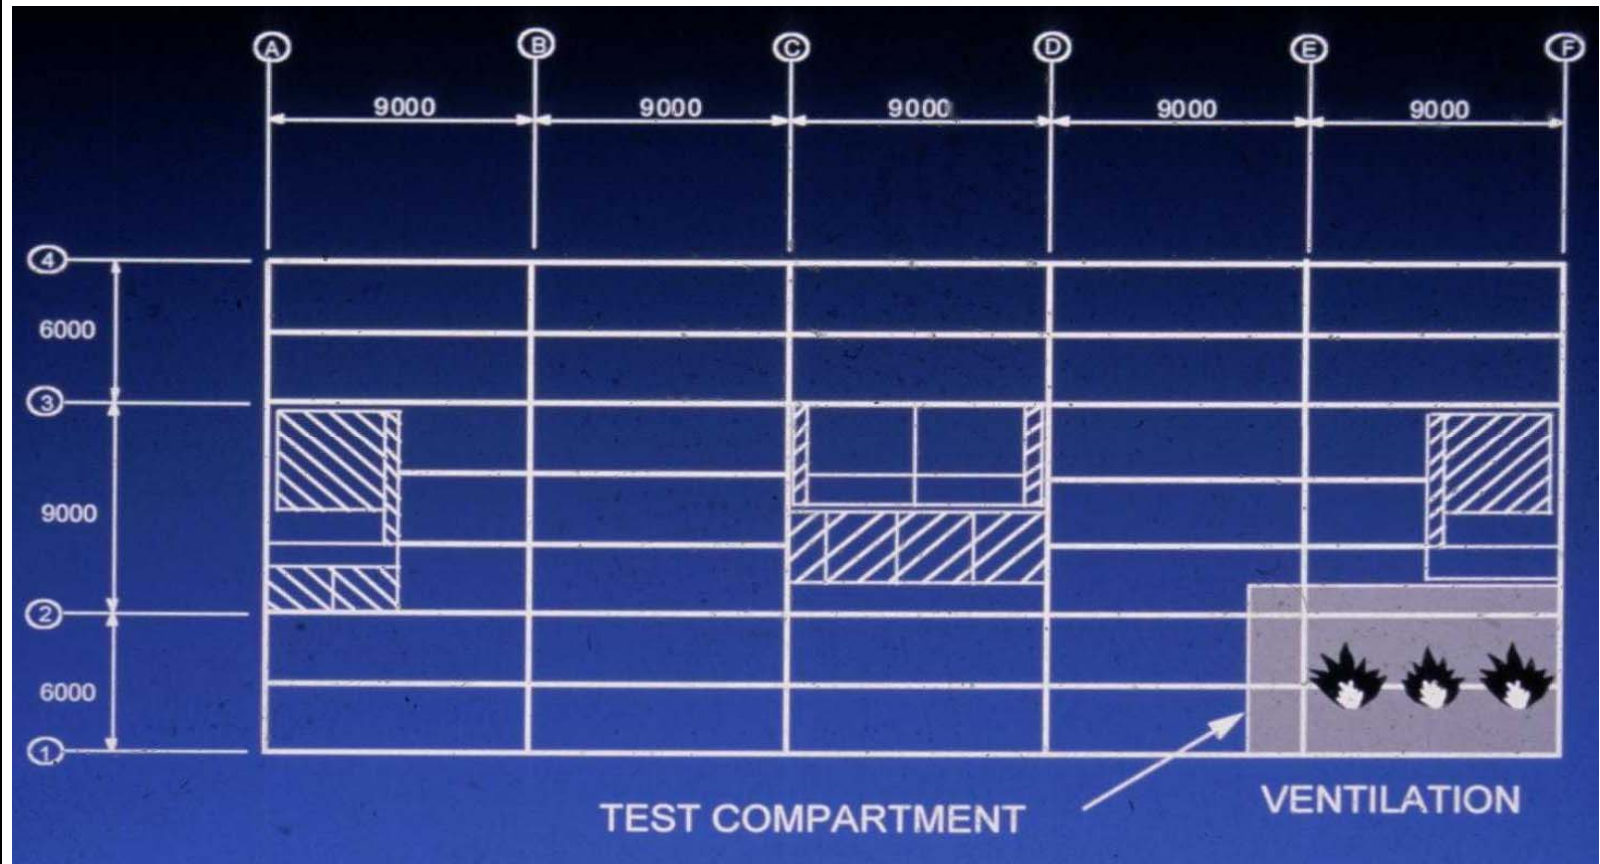
- **Corner compartment test**

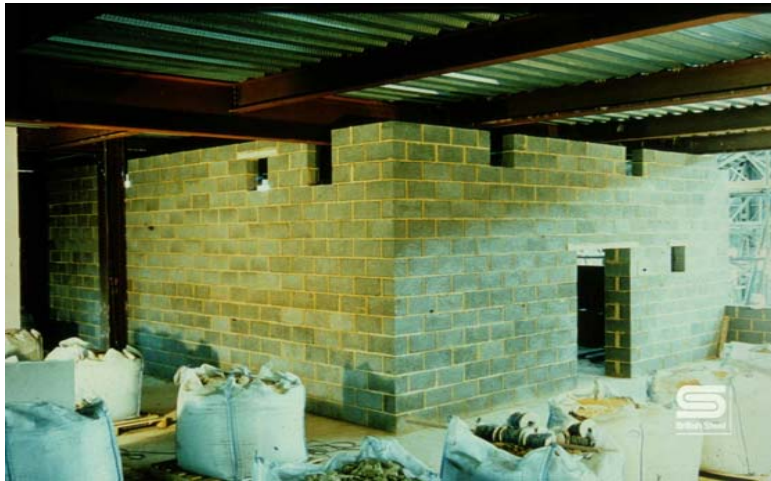
Walls of the compartment with hollow breeze-blocks

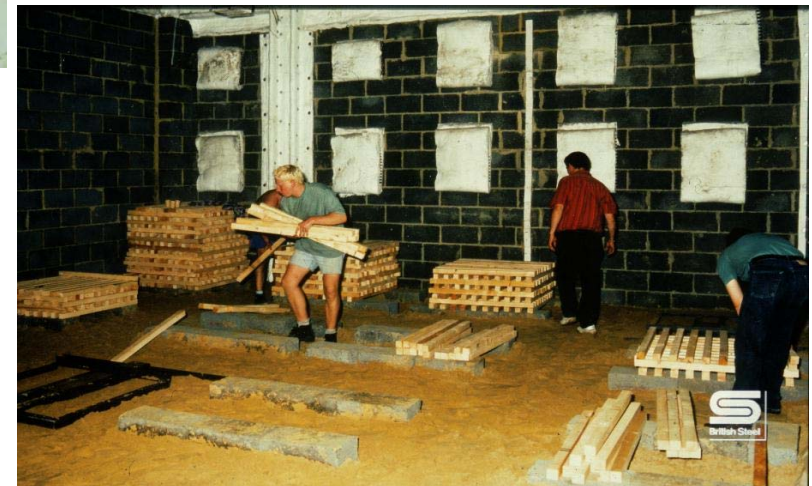
Fire load with wood cribs equals to 45 kg/m²

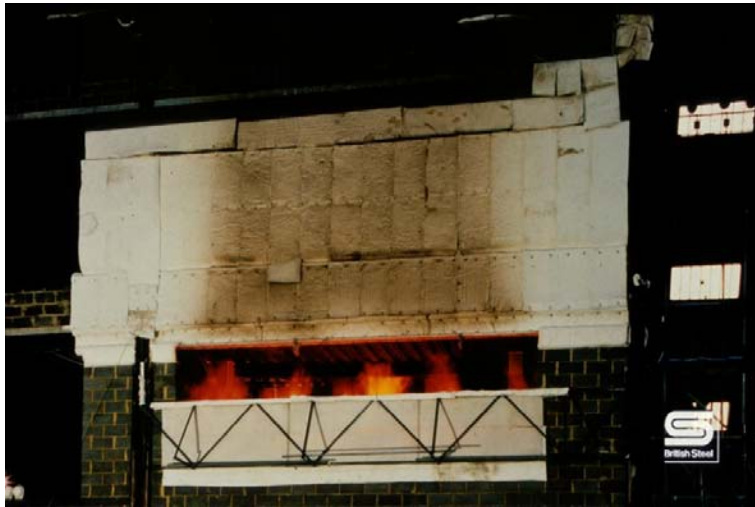
Fire during the test

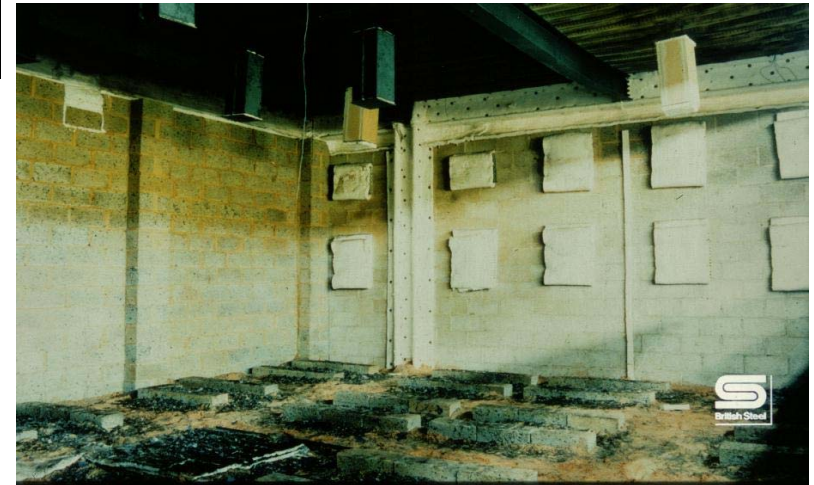
Deformed floor after the test

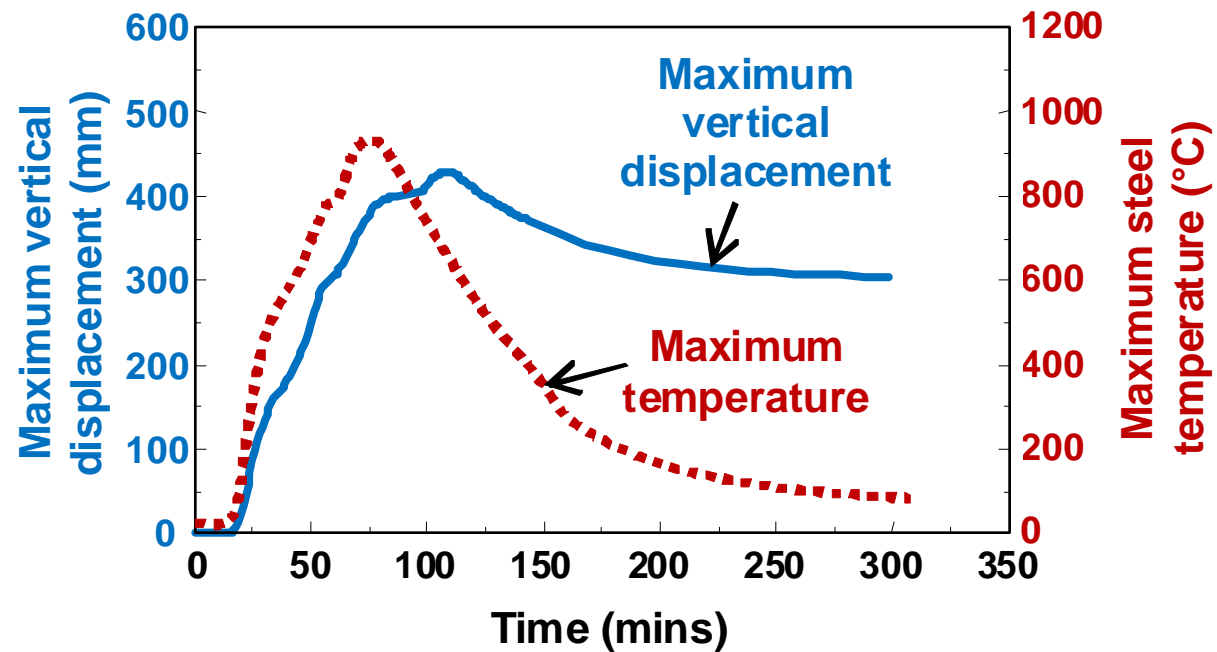
- **Corner compartment test : experimental results**

- **Observation**
 - Maximum heating of steel $\approx 1014\text{ }^{\circ}\text{C}$
 - Maximum deflection of the floor $\approx 428\text{ mm}$

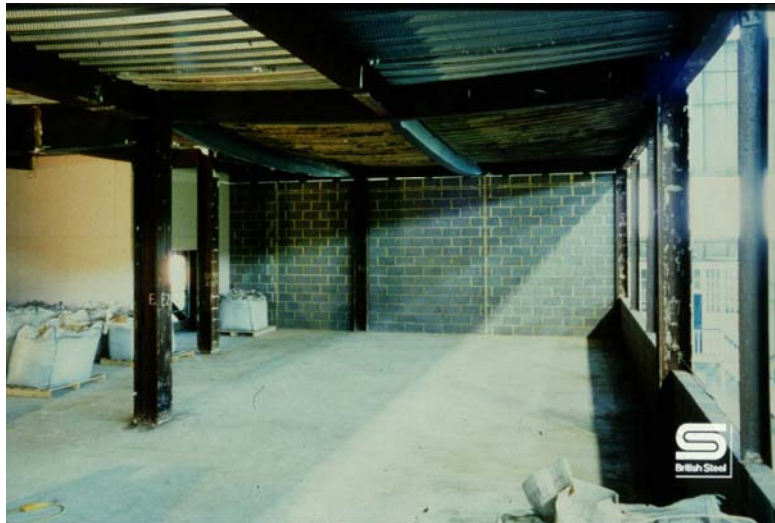
Deformed state of the heated part of the composite floor

- **Conclusion**
 - No sign of global failure of the floor as well as limited deflection of the floor despite important heating of steel

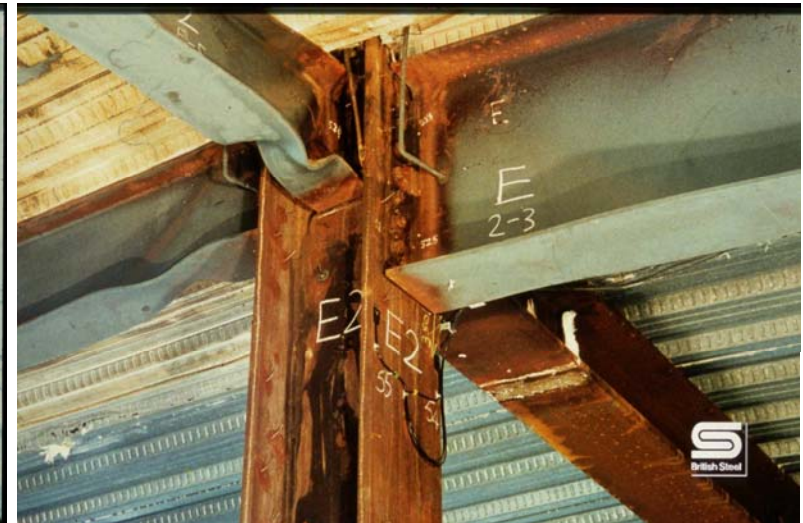
Deformed state of steel members around protected steel column

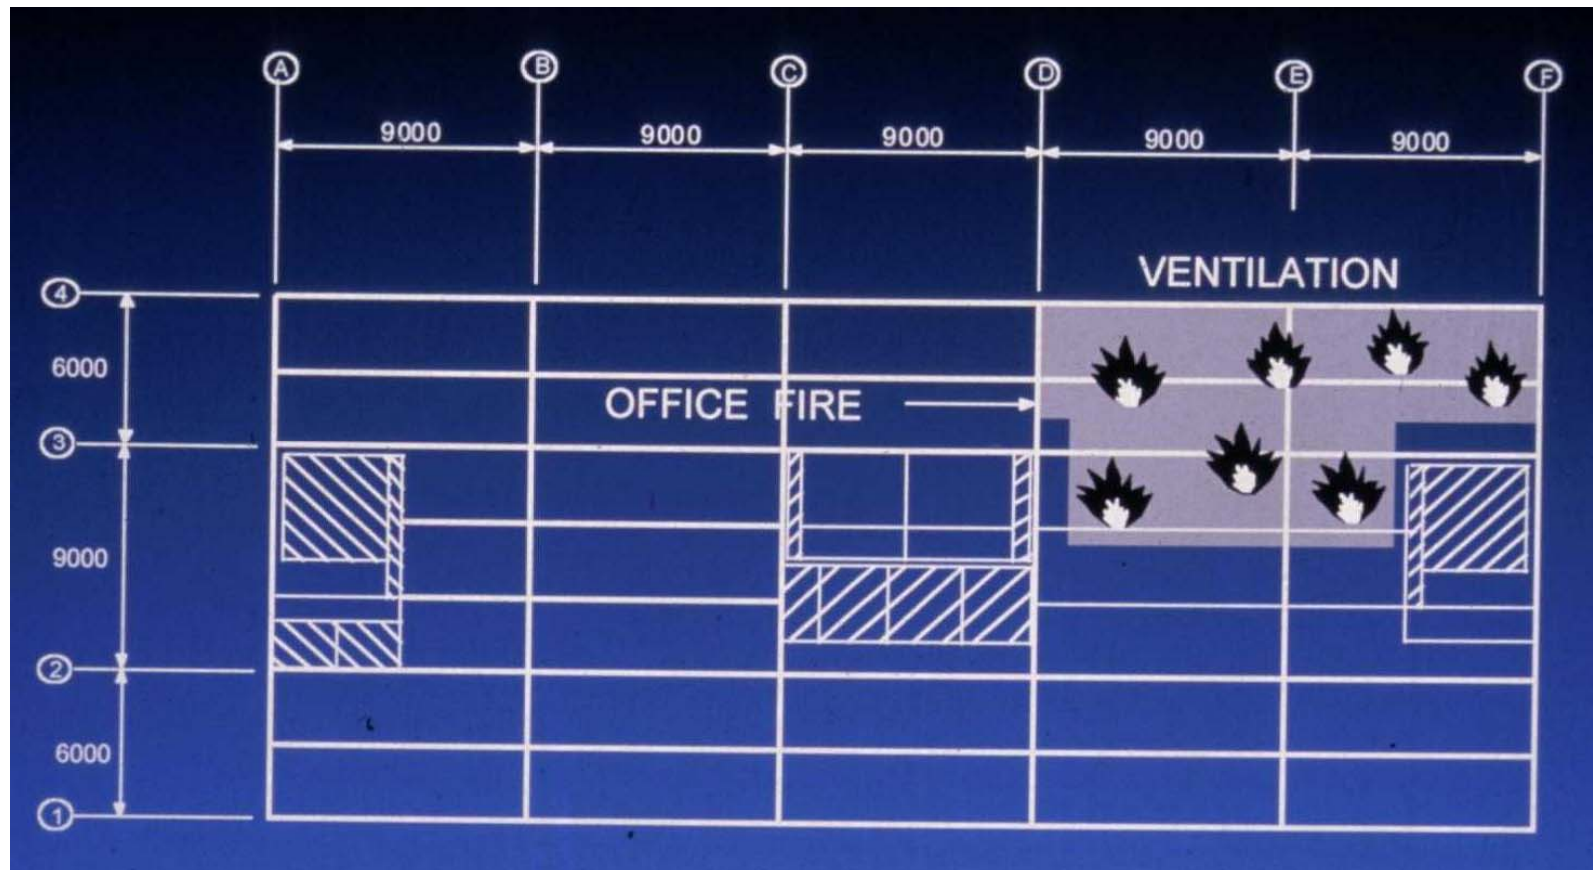
- **Demonstration test (an area of more than 130 m²)**

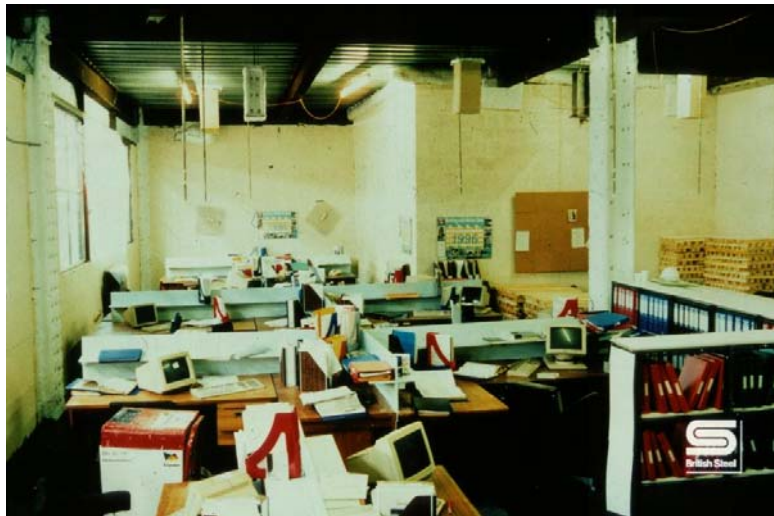
**Fire load with real
office furniture**

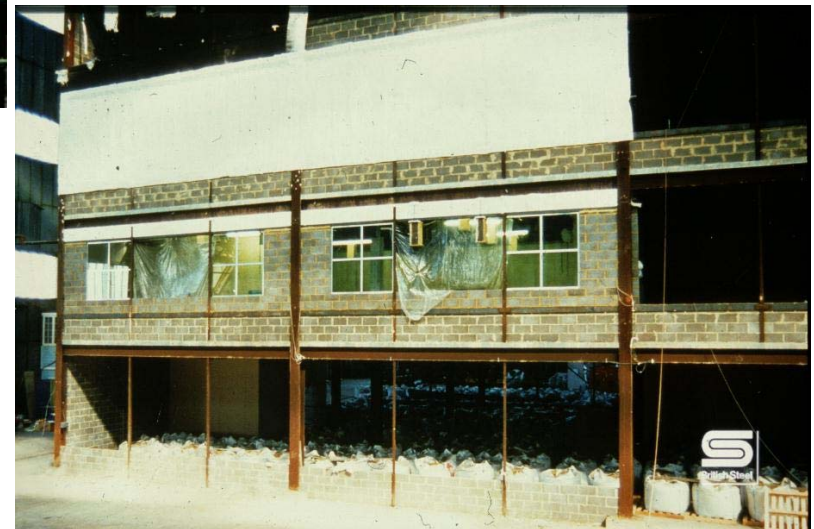
**Openings with normal
glazed windows**

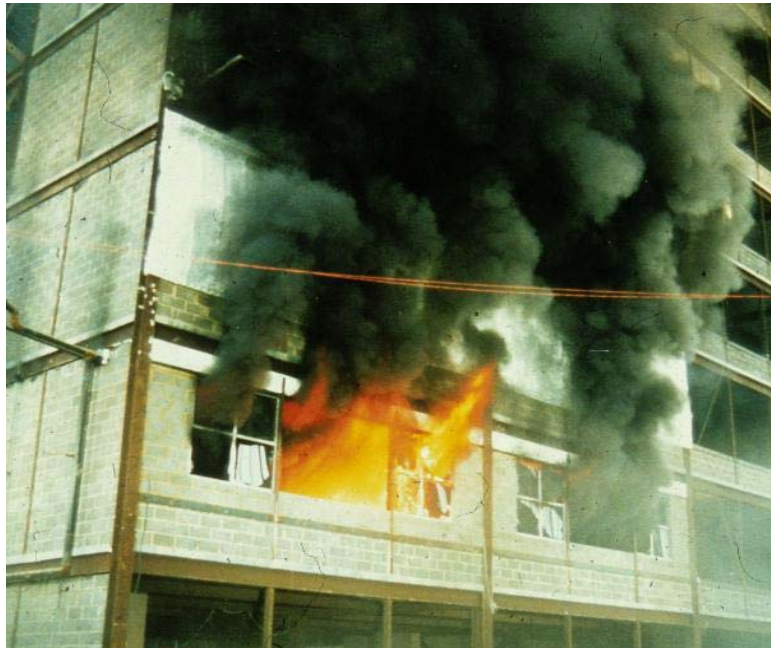
Early stage of fire

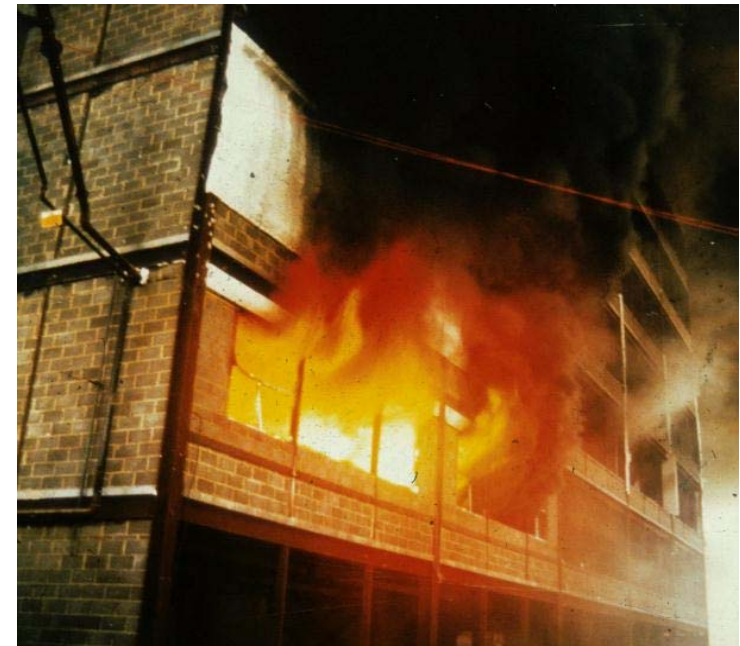
Fully developed fire

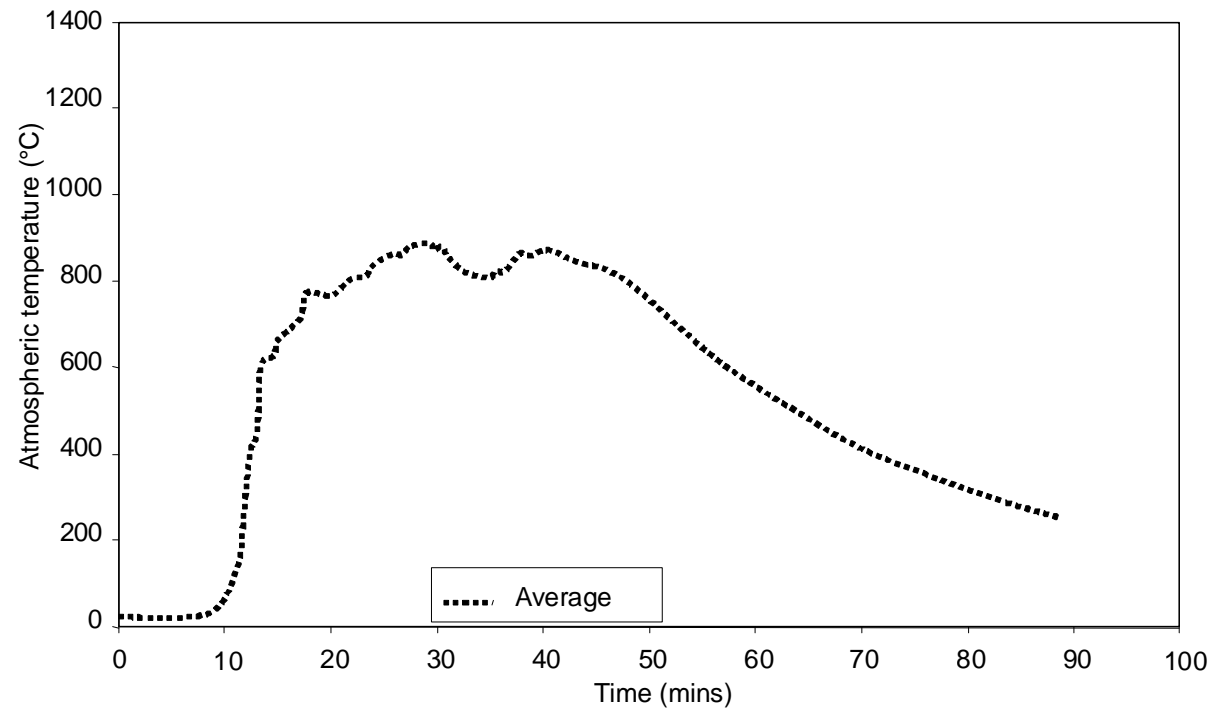
- **Demonstration test : experimental results**

- **Observation**
 - Maximum gas temperature $\approx 1200^{\circ}\text{C}$
 - Maximum heating of steel $\approx 1150^{\circ}\text{C}$

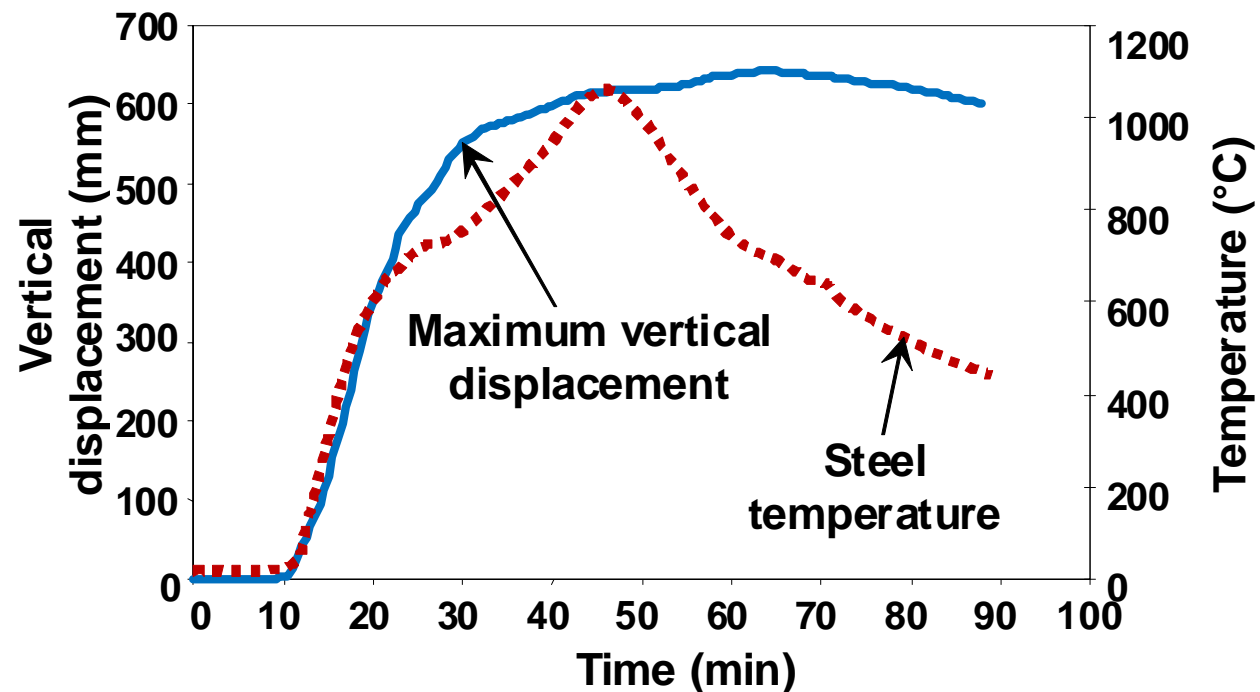
- **Demonstration test : experimental results**

- **Observation**
 - Important deflection of the floor ≈ 640 mm
 - No collapse of the floor

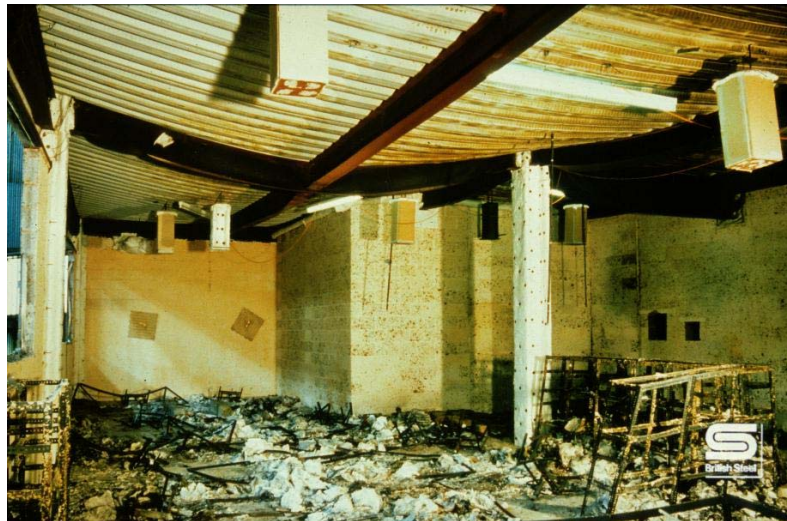
Deformed state of the heated part of the composite floor

- **Conclusion**
 - **No sign of global failure of the floor despite important heating of steel and deflection of the floor**

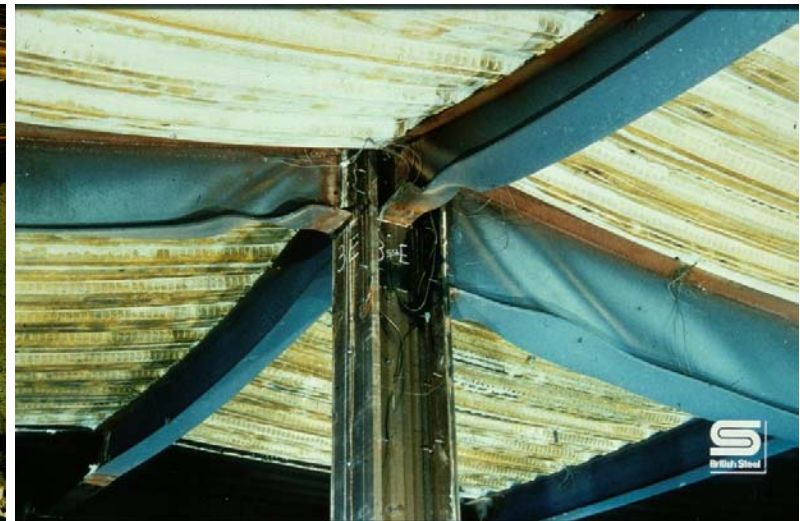
Deformed state of steel members around protected steel column

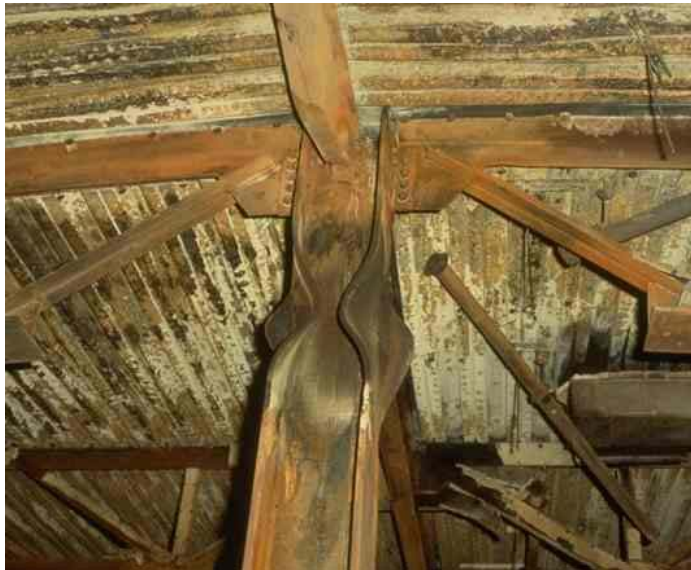
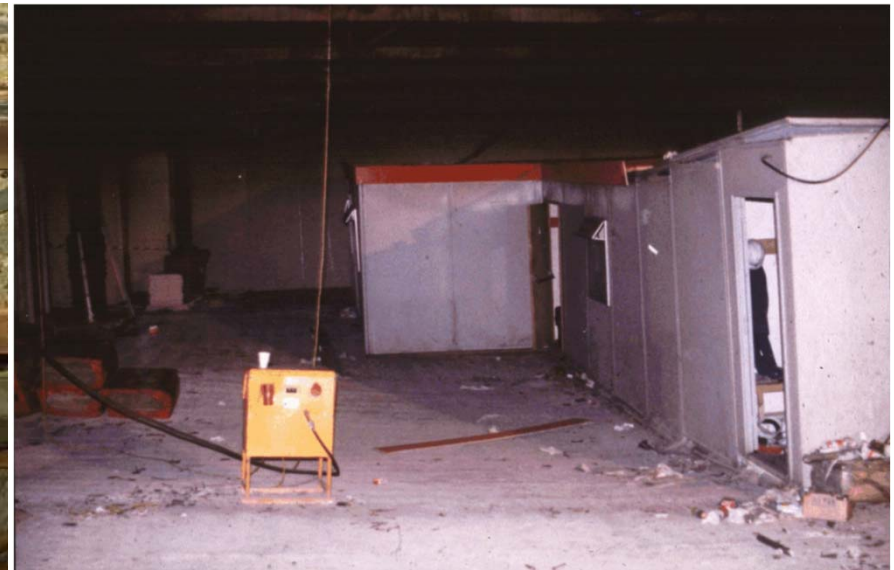
- **Broadgate fire**
 - 14 storey-office building with composite floor system
 - Fire temperature more than 1000 °C
 - Important deflection of the floor (more than 600 mm) but no collapse
